Subject: Re: Wanted: info/source for balance staff, 1907 VE pocket watch Posted by Case on Tue, 03 Sep 2019 17:33:43 GMT

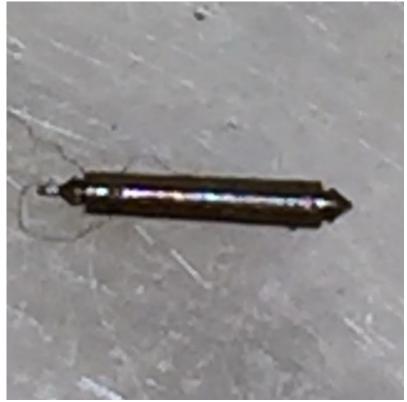
1) 1907 Balance staff (broken).JPG, downloaded 2014 times

Here's a visual of the broken staff.

Also, thinking longer term of getting this into a CAD file and finding a CM. Such a simple design. Any recos?
