Subject: Re: Wanted: info/source for balance staff, 1907 VE pocket watch

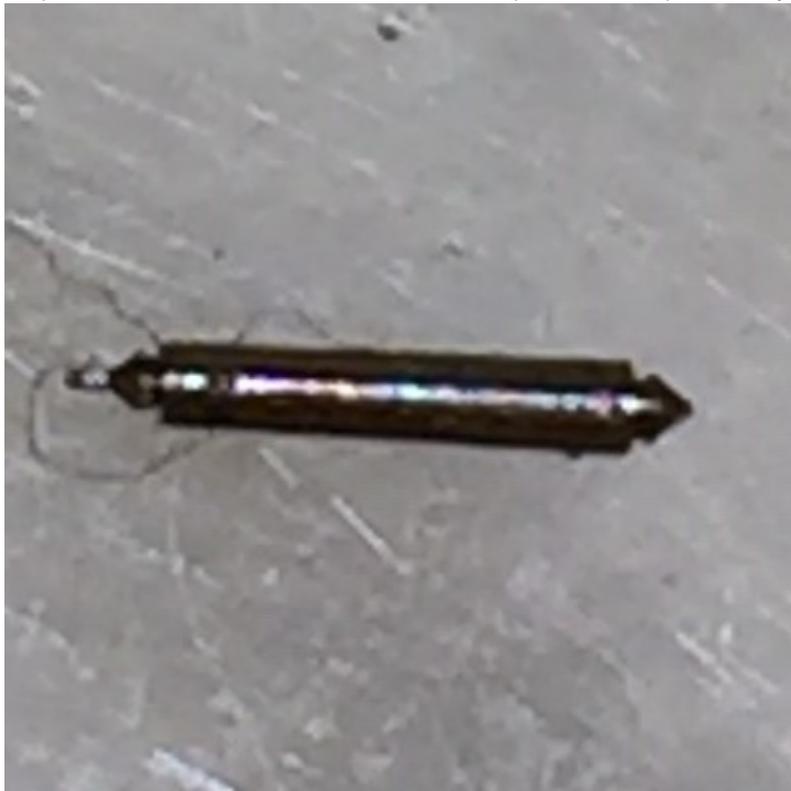
1) [1907 Balance staff \(broken\).JPG](#), downloaded 2502 times

This story is just too true to be good. Not a match; on to plan C. BTW, the only visual indicator from the top side on the stud carrier is the hole: the Madretsches has a perfectly round hole for the hairspring, while the later (non-matching) movement has semi-circle with one flat side. Difference is visible in images above.

Here's a visual of the broken staff.

Also, thinking longer term of getting this into a CAD file and finding a CM. Such a simple design. Any recos?
