Subject: Re: Curvex Duchess 1937 520 Posted by koskid on Thu, 31 Oct 2024 19:49:10 GMT View Forum Message <> Reply to Message

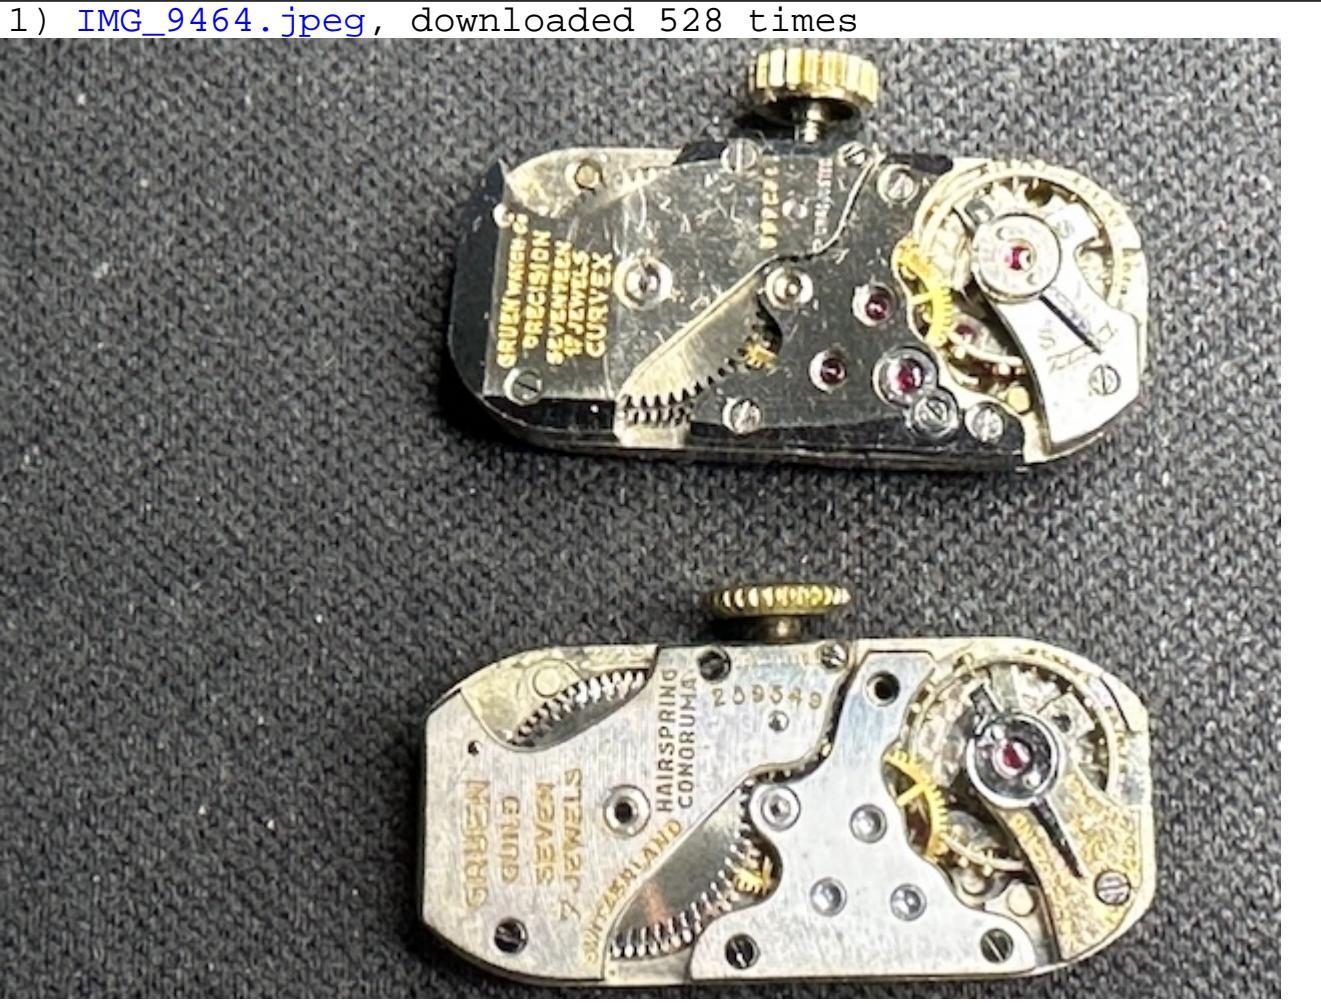
Attached is a photo of both the 520 (top) and 329 (bottom) movements. The 520 has the balance cock and balance from the 329 installed and is running great. The broken staff 520 balance cock and balance are installed in the 329. The upper bridges on the 520 have a cylindrically machined surface to fit the curves case.
