Subject: The Caliber UltraThin Posted by thesnark17 on Mon, 25 Apr 2022 23:46:09 GMT View Forum Message <> Reply to Message

## Take two!

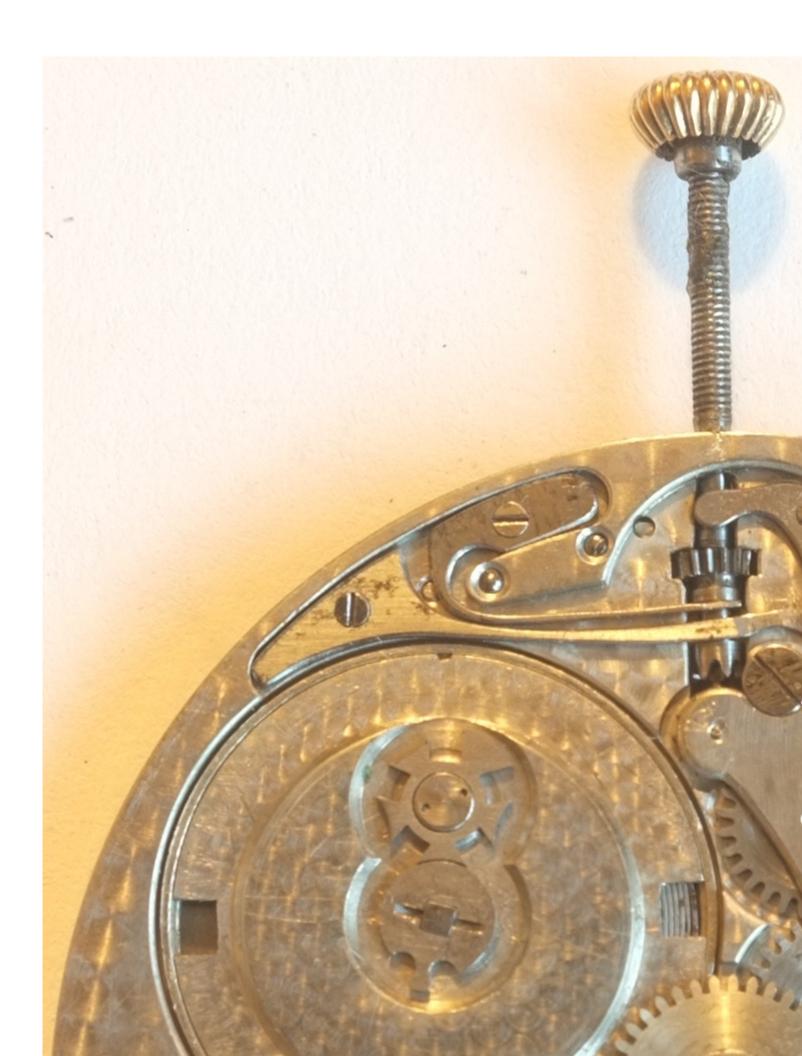
File Attachments
1) UT dial side.jpg, downloaded 1760 times

Here's the dial. Showy, but understated.

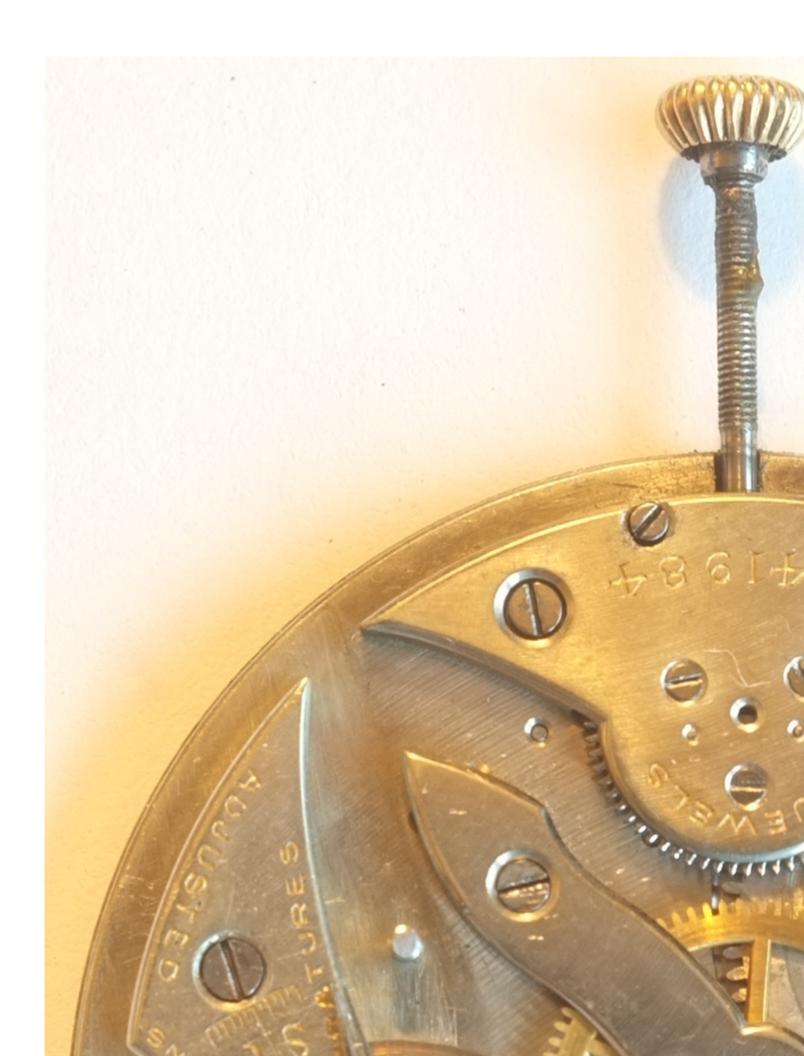
## 2) UT mvt.jpg, downloaded 1703 times

The first issue makes its appearance - the movement runs +5 seconds a day across three positions in this regulator position. Bad restaffing, tsk, tsk. The "stud" by the balance cock is also too long, because it is actually just a screw that's been driven partway through the plate.

Ouch. Yes, that's epoxy, holding the balance jewel setting in place... who would do such a thing?! Both caps are messed up, and may not even be the right ones, or right screws... they sure don't seem to fit very well.

Don't get too carried away with this one - the delta across 5 positions is >250 seconds, and the beat error is so bad that it won't self-start, even at full wind. The dangers of shoddy watch repair... so much for Extra Precision!

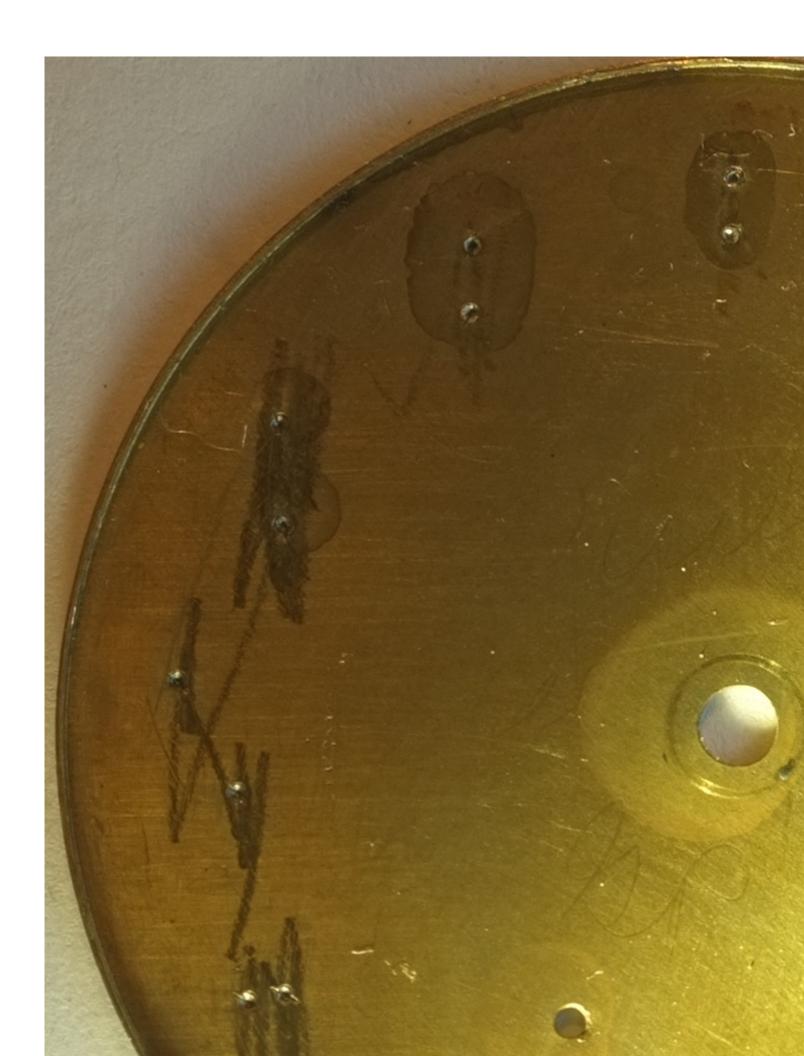
## 3) UT dial back.jpg, downloaded 1737 times

Of interest, the dial is marked with the movement serial number, and also has light cursive engraving that says "Gruen Su-" (cut off into the center hole) and then some stuff I can't make out (Gp 421???). You can kind of see it in the photo.
