Subject: The Caliber UltraThin

About 1,000 early UltraThins were made, between SN 41,000 and 42,500. They are impressively thin, and impeccably finished throughout. Some (perhaps half) are graded Extra Precision, like this one. It is unknown whether the later UltraThins in SN 148-150k and 185k are the same in all respects. There are also UltraThins at SN 13,7xx - another mystery how they compare.

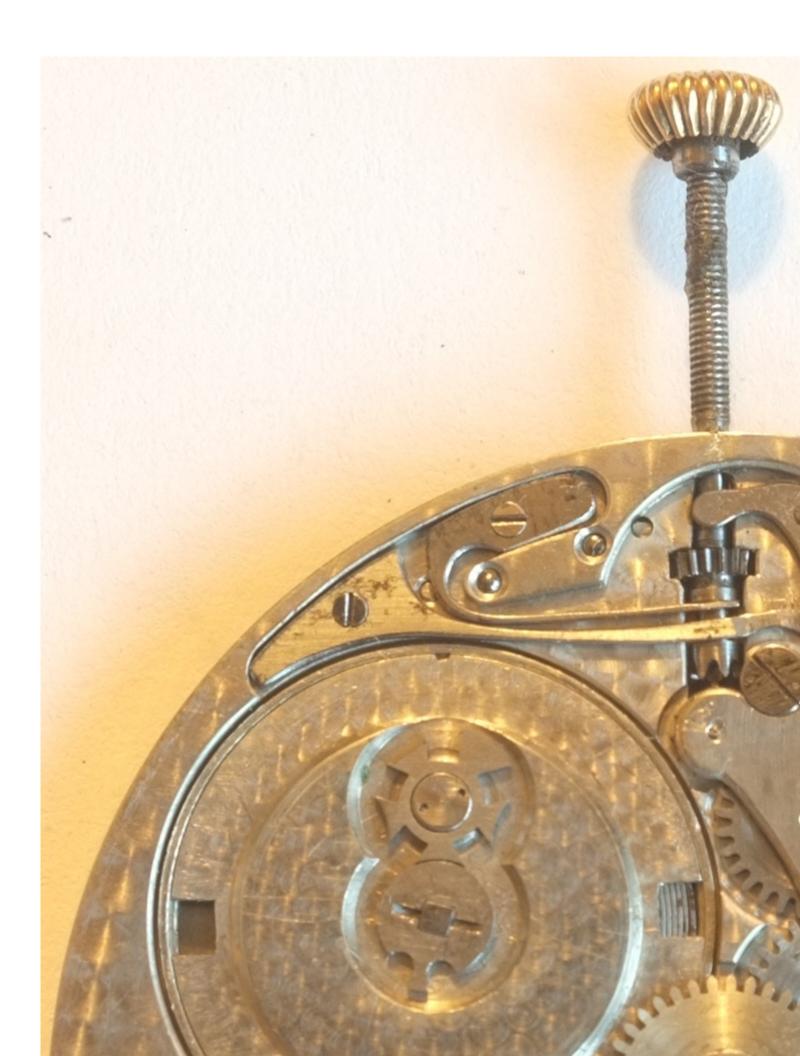
1) UT dial side.jpg, downloaded 2090 times

Here's the dial. Showy, but understated.

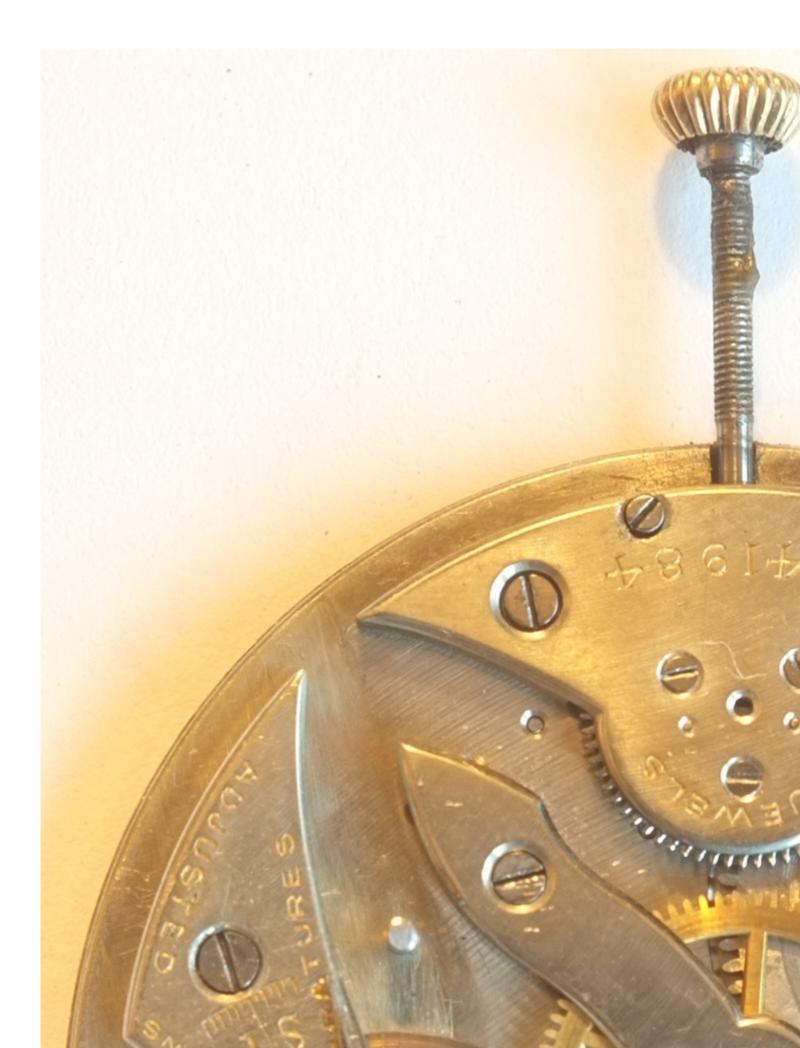
The first issue makes its appearance - the movement runs +5 seconds a day across three positions in this regulator position. Bad restaffing, tsk, tsk. The "stud" by the balance cock is also too long, because it is actually just a screw that's been driven partway through the plate.
